OMI OPERATIONS STATUS

Jacques Claas
Instrument Operations Team
KNMI
The Netherlands

MOWG
12 September 2006
Boulder

FMM anomaly: overview

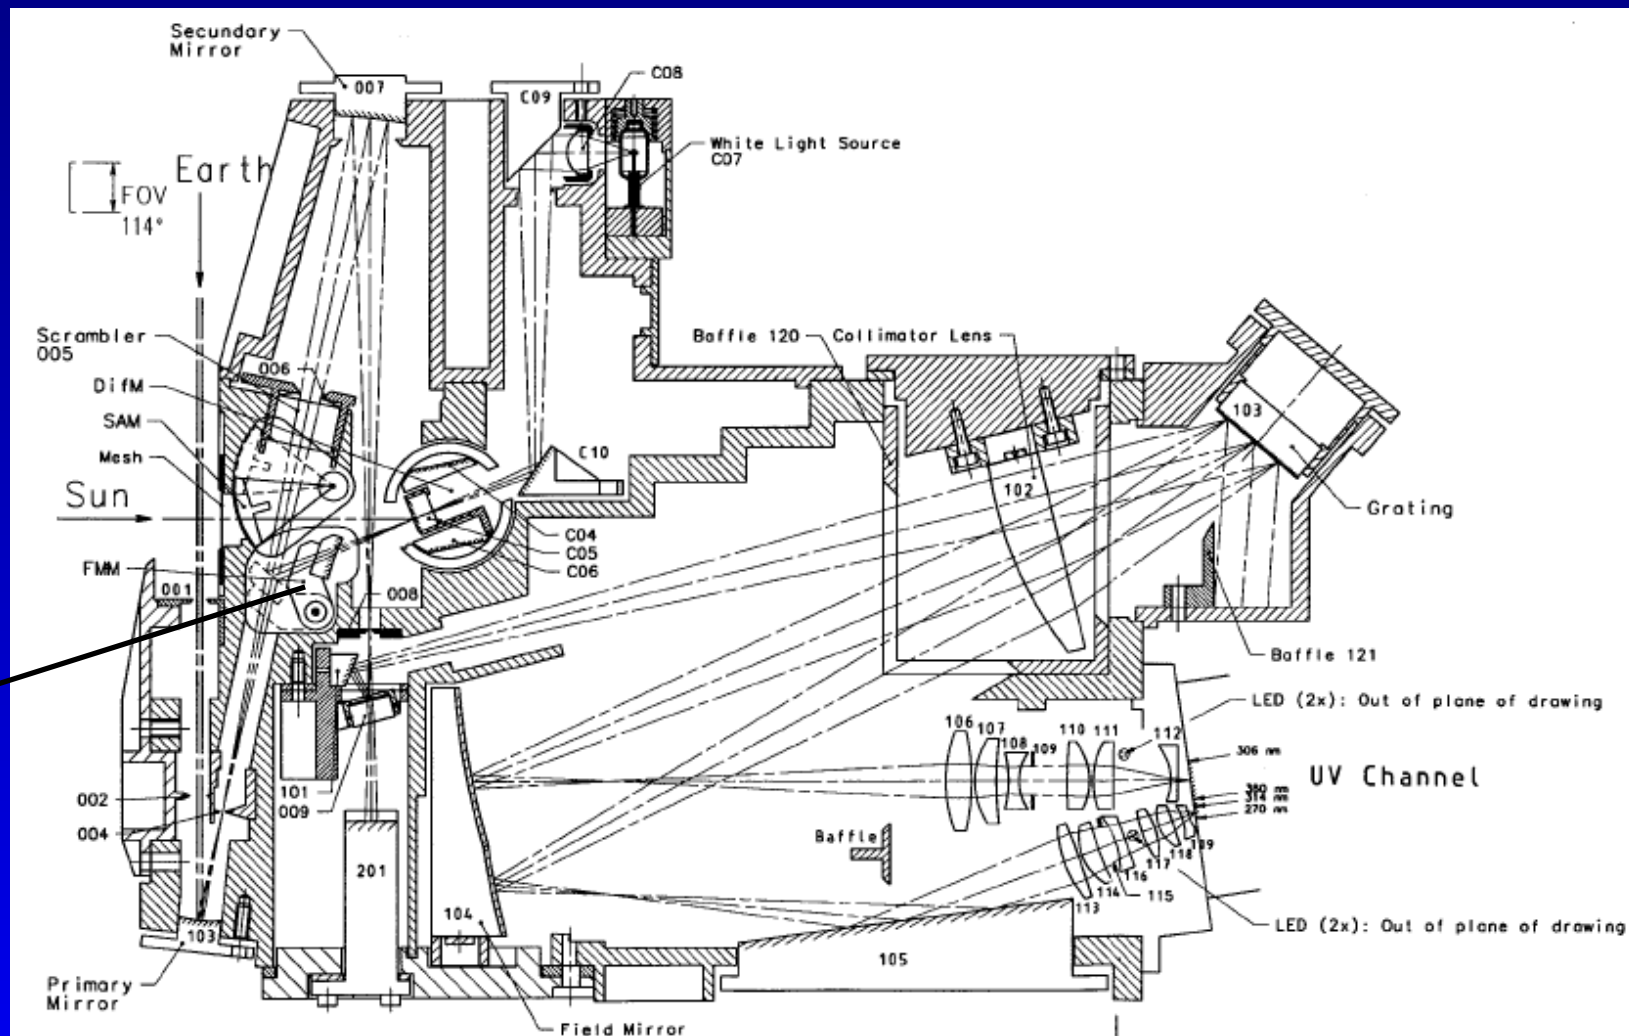
Design drawing of the OMI optical bench

The FMM is a stepper motor. It is needed when performing calibration measurements

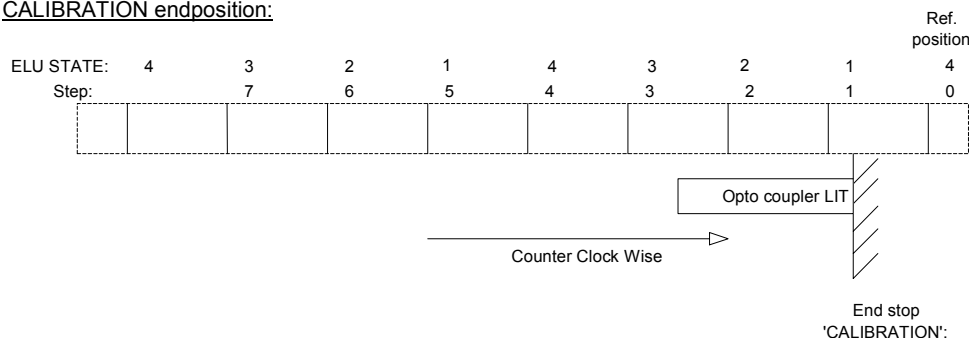
CALIBRATION endposition:

- Telemetry analysis showed that the FMM, as part of the Fault Management procedure, was indeed moved to nadir position.
- This was confirmed when, after March 3rd, earth images became available again which showed that the optical path was not blocked by the FMM.
